Supplemental Report: Jason Ravensborg/Joseph Boever Fatal Pedestrian Crash on 09/12/2020

Overview of Activity

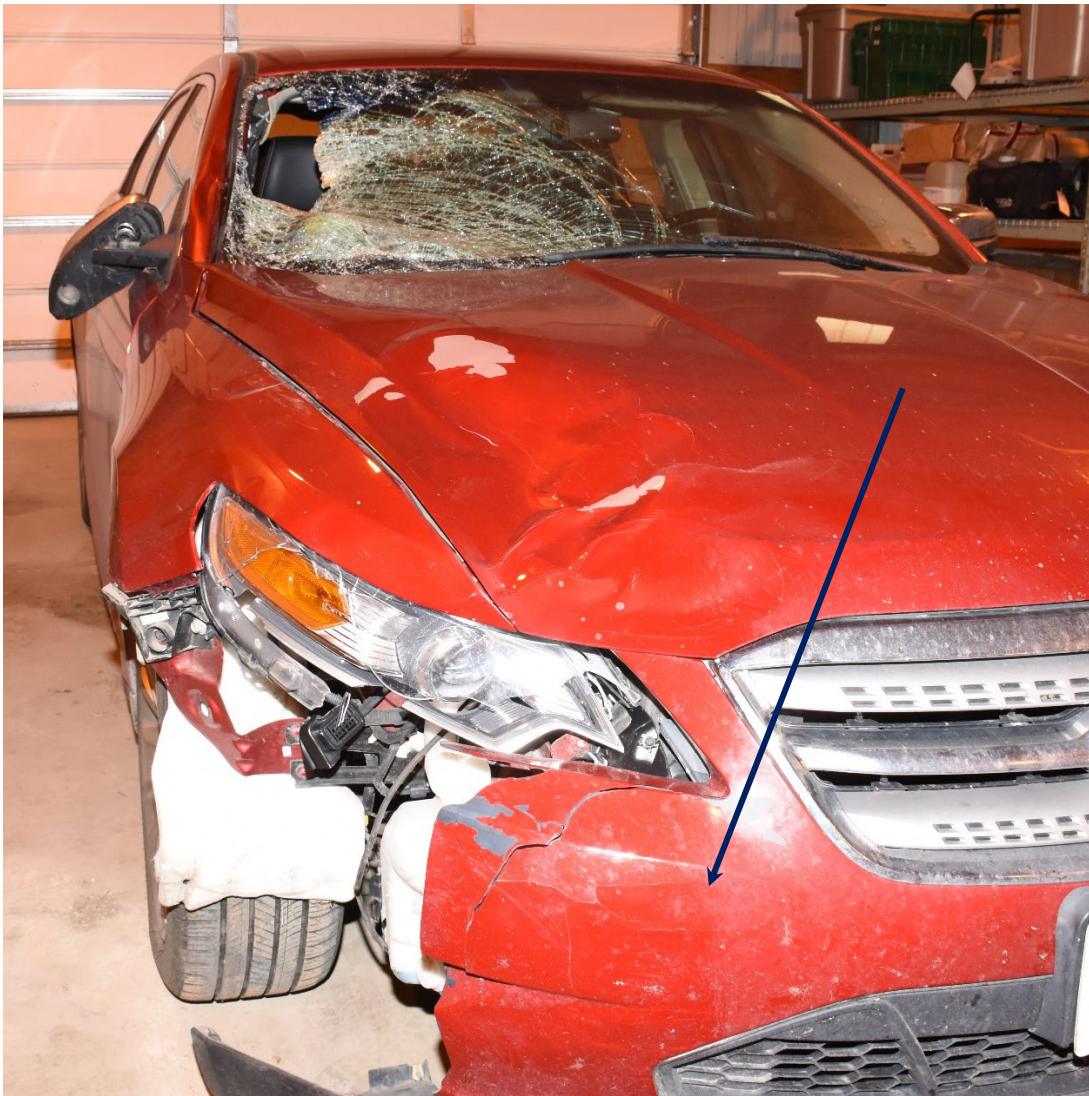
Figure 2: Picture of AG Vehicle from Front; Arrow indicating area where dust was wiped off.

After the completion of skid testing, I utilized the Leica C10 ScanStation to complete a 3D forensic scan of the vehicle. I scanned around the vehicle in six locations and later did the work to combine the scans. TRP Berndt needed to know a measurement of how far in from the passenger side of the vehicle the damage extended. Using the picture in Figure 2 we could see where the dirt/dust had been brushed off the front bumper of the vehicle. I used this information to get a measurement from the forensic map that was completed. Figure 3 is a top-down view of the vehicle. Figure 4 is a front view of the vehicle.

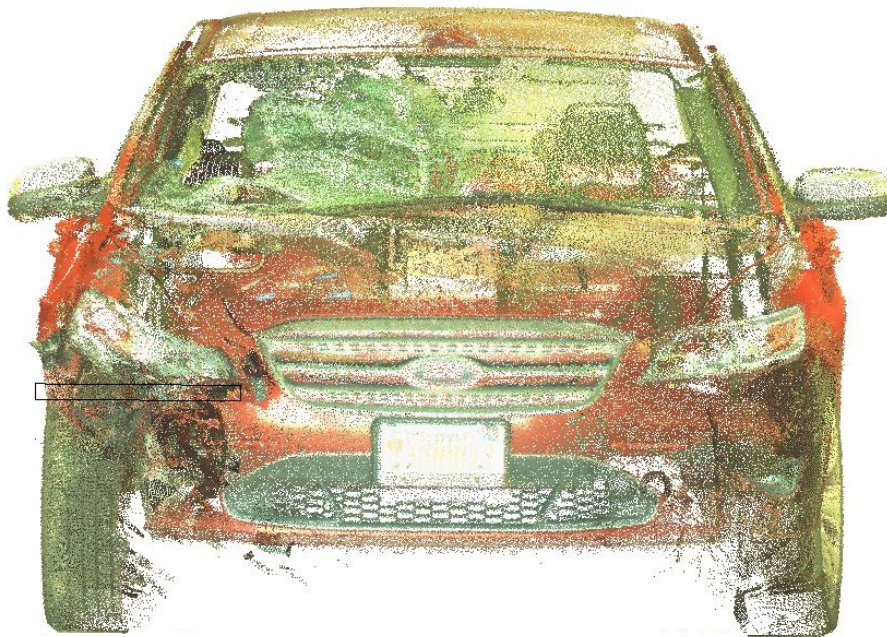
Figure 4: Front view of AG Vehicle Scan; Black rectangle is width of measurement from Figure 3.

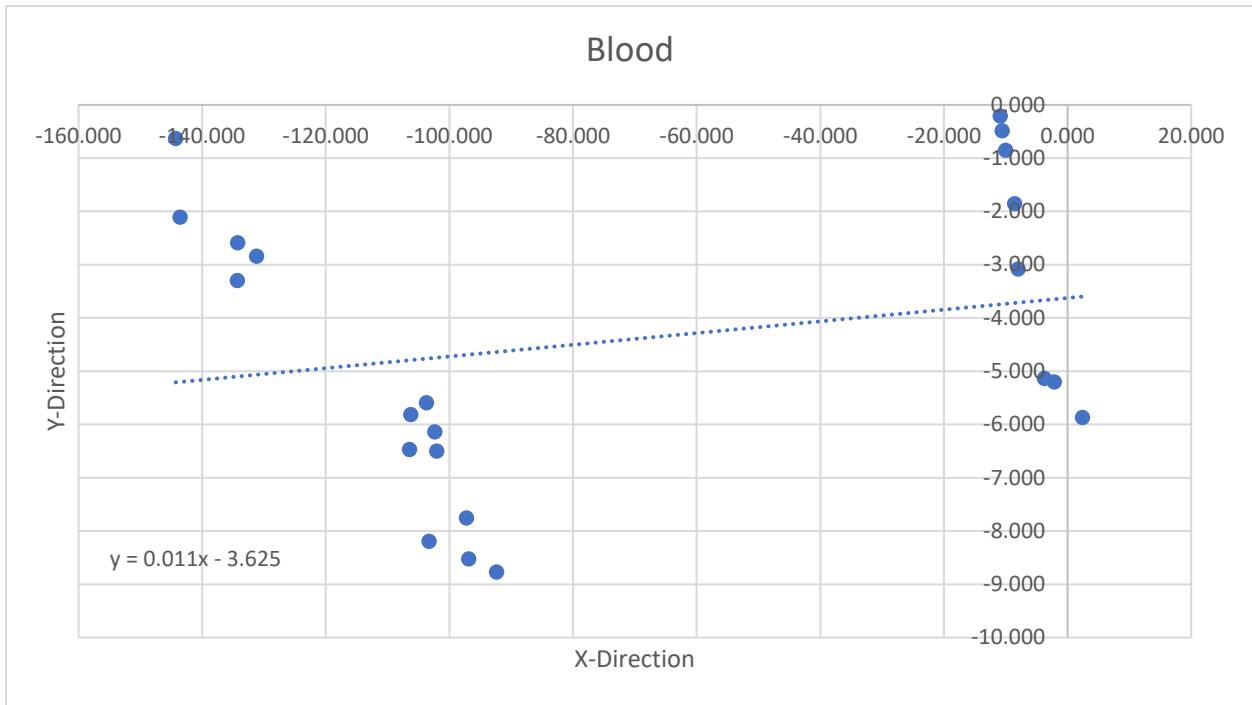
Figure 5: Blood Evidence Type

The evidence on the shoulder of the roadway assists us in locating the area of impact and the direction of travel for the vehicle. One of the concerns was if the mild wind through the evening could have changed the location of any of the pieces that were there, particularly the paint chips. The evidence was broken down into reddish-brown substance (presumed to be blood in the remainder of the report), car parts, and paint chips by importing the forensic mapping log into Microsoft Excel. A tab for each type was created from the main forensic log that was copied and then reduced down to represent each respective category. A chart was created on each tab to represent the layout of those evidence points in the x-direction and y-direction. A linear trendline with its equation was added to show the average direction of travel because we know that evidence patterns start narrow and spread out as it continues moving to final rest. Each of the representative types are shown below; Blood (Figure 5), Car Parts (Figure 6) and Paint Chips (Figure 7).

Blood (Reddish-Brown Substance) [Equation from Figure 5: $y = 0.011x - 3.625$]

- Point 1 (0, -3.625)
- Point 2 (-170, -5.495)
- Angle should be 180.63°

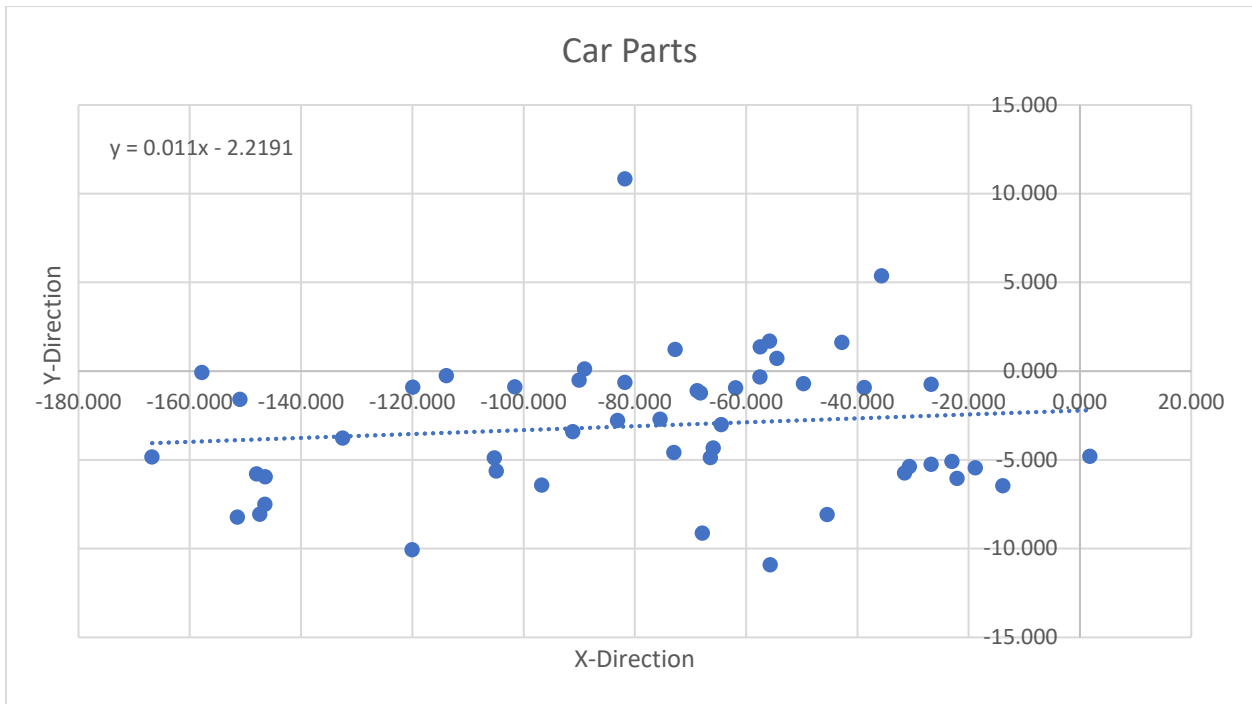
Figure 6: Car Parts Evidence Type

Car Parts [Equation from Figure 6: $y = 0.0024x - 3.078$]

- Point 1 (0, -3.078)
- Point 2 (-170, -3.486)
- Angle should be 180.14°

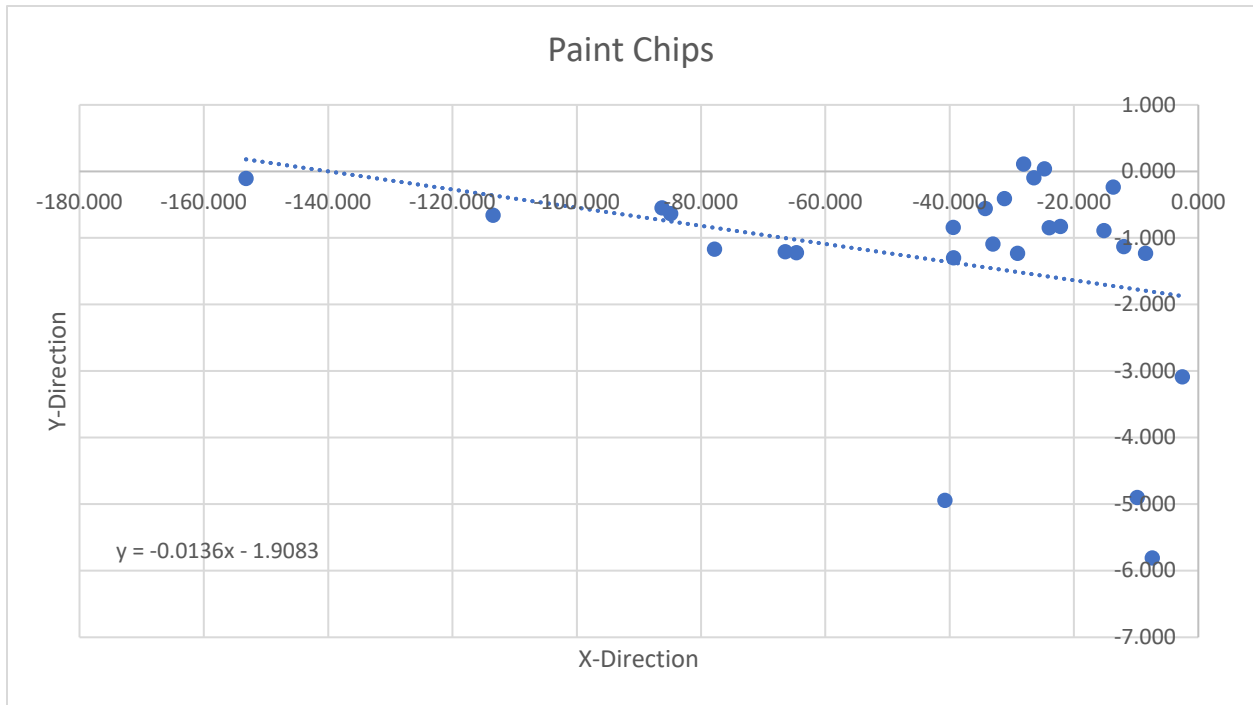
Figure 7: Paint Chip Evidence Type

Paint Chips [Equation from Figure 7: $y = -0.0136x - 1.9083$]

- Point 1 (0, -1.9083)
- Point 2 (-170, 0.4037)
- Angle should be 179.99°

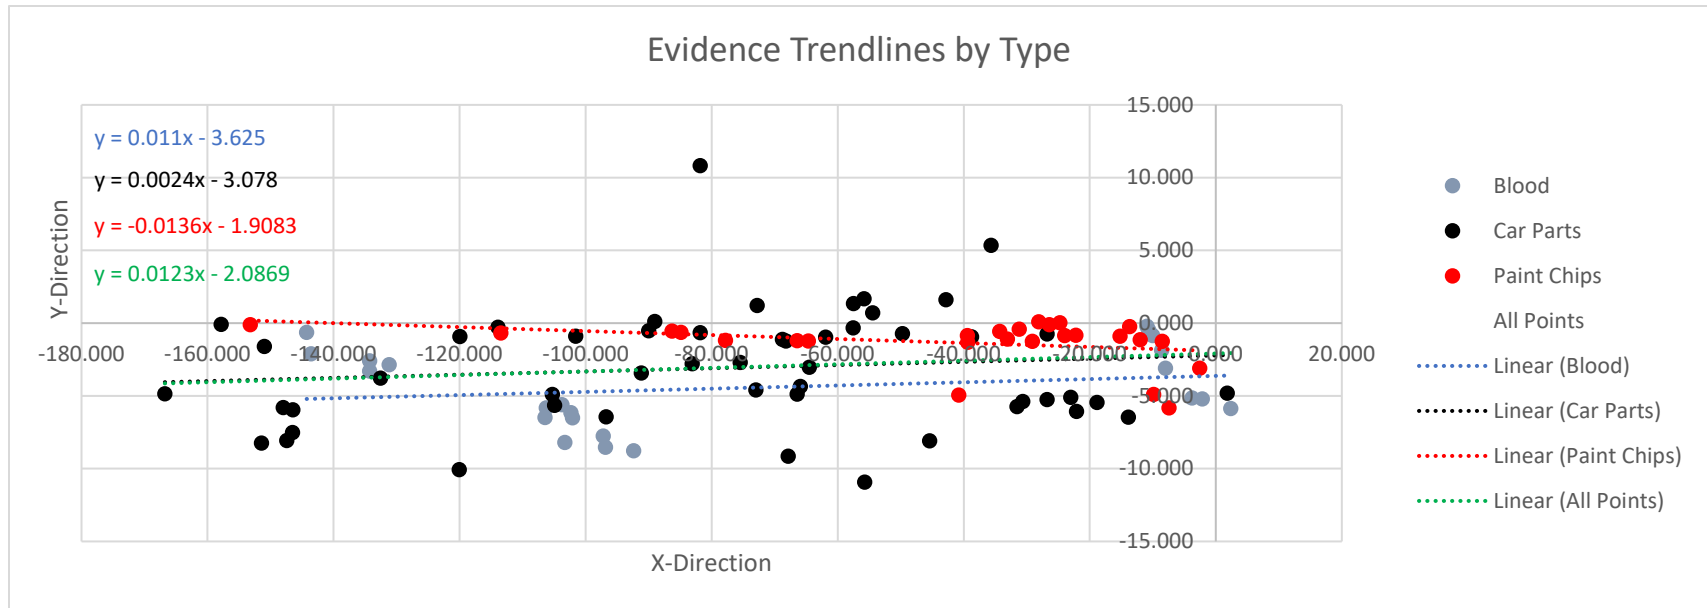
Figure 8: All Evidence by Types

When each type had been completed, a tab that compiled all the types onto a single chart was created for comparison (Figure 8), which can be seen on the previous page. This chart is not set to an equal scale in the x-direction and the y-direction, so the angles of the trendlines can be deceiving. To help visualize the angles, the equations were used to calculate points on the forensic map that could be drawn to scale. The information used is presented here:

All Points [Equation from Figure 8: $y = 0.0123x - 2.0869$]

- Point 1 (0, -2.0869)
- Point 2 (-170, -4.1779)
- Angle should be 180.70°

The maximum difference between the angles is $180.63^\circ - 179.99^\circ = 0.64^\circ$. I used 180.63° instead of 180.70° because it is the difference between all the points separated versus the one with all the points included. It's amazing how tight the difference is when separated, which gives a higher confidence that the paint chips probably didn't move much in comparison to the other evidence types. This also gives us a high confidence that the direction of travel would have been straight west down US14 at the time of impact. This information was given to TRP Berndt to plot on the forensic diagram.
